Preservation & Stabilization of The Hollow, Summer 2009

Prepared October 2009 by local project manager/architectural historian Cheryl H. Shepherd

Representing *Preservation Virginia* & Dr. & Mrs. David C. Collins

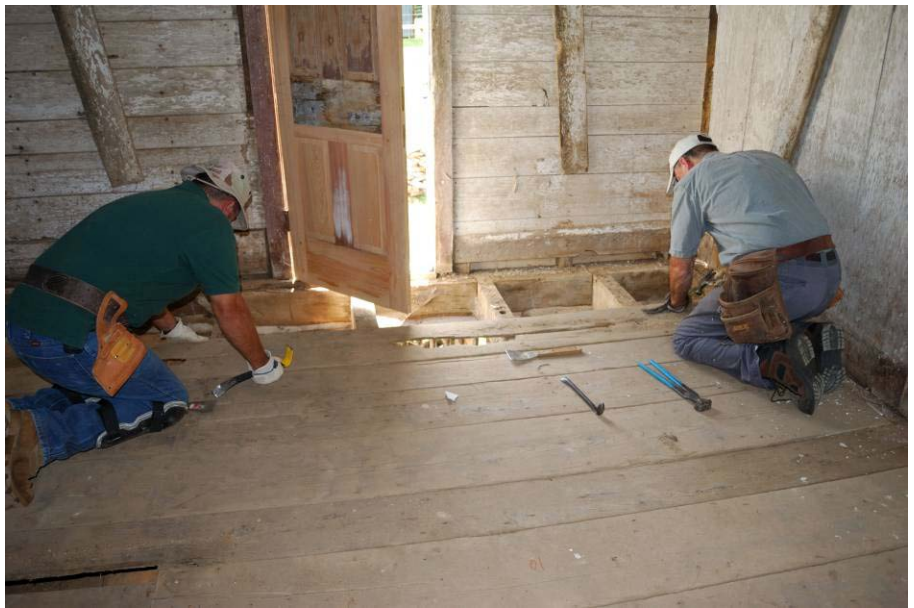
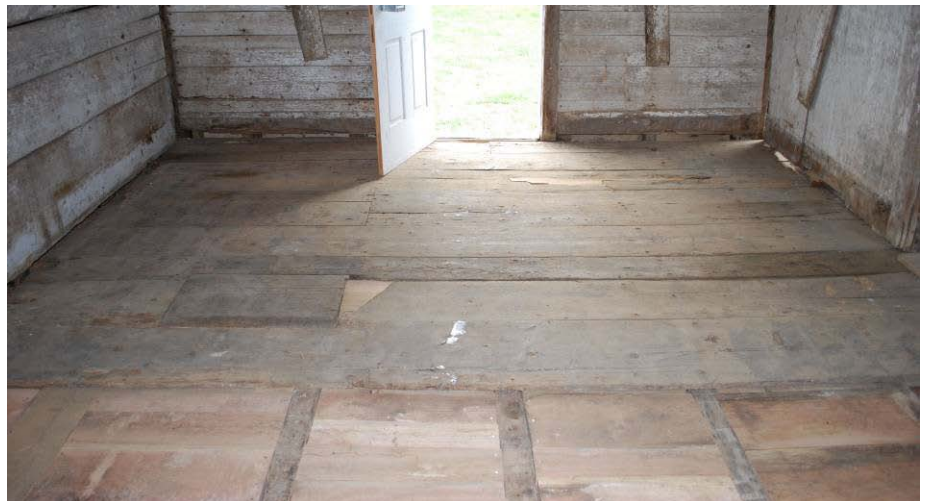
Pictured to the right, Karl and Mike carefully take up the 19th-century floor boards in the east parlor. The lower view shows the floor after they laid boards back into position on the front floor joists that received narrow wood strips on their sides to support reinforcement boards, as shown in the foreground. This strengthening method allowed them to save the old floor boards, even those with large holes. Although now two layers exist, the floor height remains the same, and the door swings easily open. Scholars can still read the tool marks and nail evidence in the preserved 19th-century floor in this room.

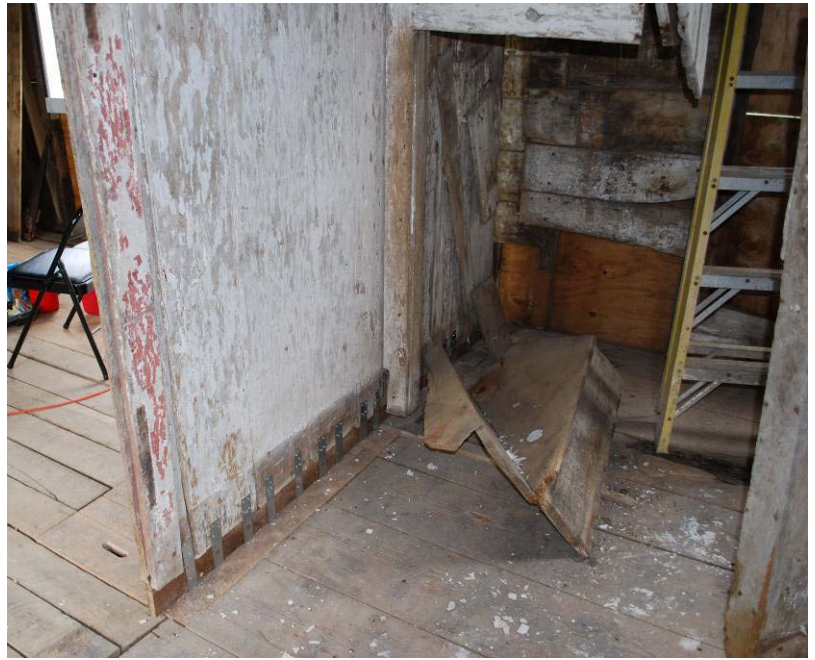
Next, these accomplished Preservation Virginia carpenters determined that the partition between the hall and parlor created a safety issue in its crude disconnection to the floor and ceiling. The team decided they should bracket it to the floor and hide the modern supports with a baseboard, as exhibited in the photograph at right. The ghost of the former baseboard is clearly evident. The simplicity and seemingly impermanent situation of this wall carrying the weight of a hinged board-and-batten door understandably astounded Mike and Karl. It appears that a lay carpenter, such as William Withers who acquired The Hollow in 1792, crudely relocated the wall to this side of the hall with the flip of the bottom steps into the east parlor and the move of the back door a few feet to the east. The reason for such arduous alterations in the late-18th - or early 19th-century still astonishes the team.

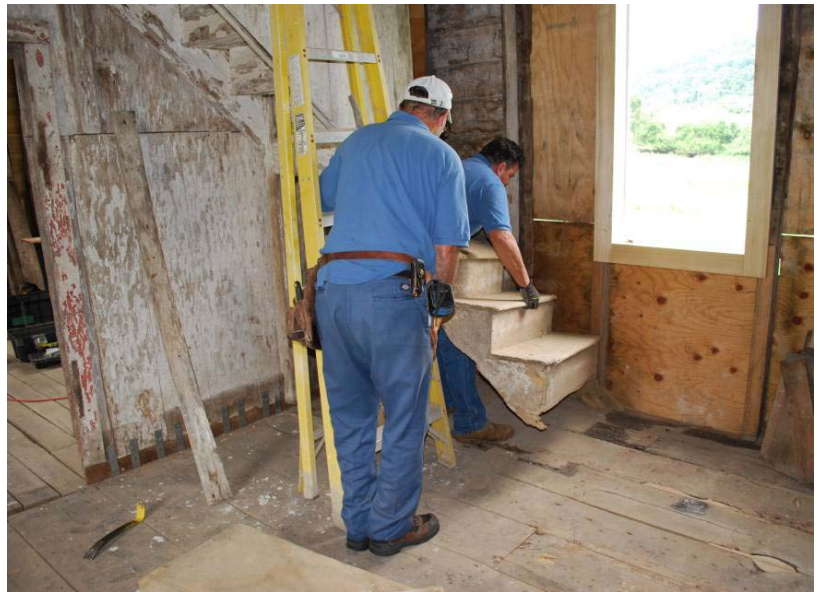
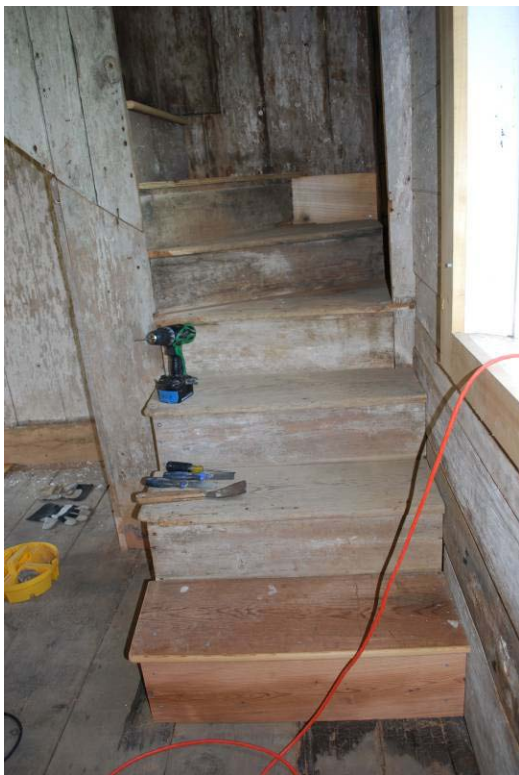
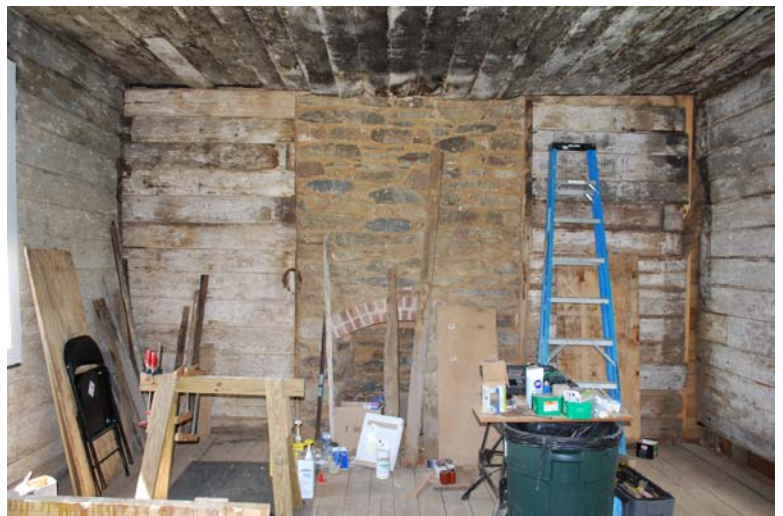
Furthering their work in August, Mike and Karl are shown figuring how the lower steps will fit in their return to their 2004 situation. The stabilization and righting of the heavily-shifted dwelling changed the height of the lower steps, requiring the addition of the fourth bottom step, shown below.

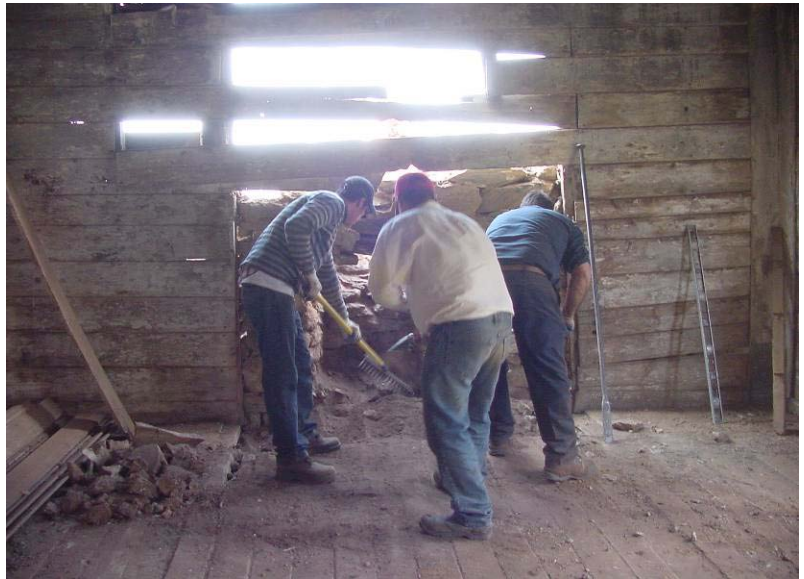
Karl proceeded to restore the beaded paneling in the west hall. Cheryl takes responsibility for the decision to slightly veer from the preservation and stabilization plan on the inside of the chimney because the period 1 fireplace opening had later been enclosed with rocks for conversion to stove heating, and wood panels across the chimney were missing or too severely compromised for reinsertion. Furthermore, since the team earlier determined not to re-form the stove flue, and to restore a brick arch over the rebuilt fireplace following brick remains in the dismantled chimney, the waiver of applying new paneling across the masonry seemed more appropriate. The condition of this feature is exhibited in the photograph at right, taken in March 2004.

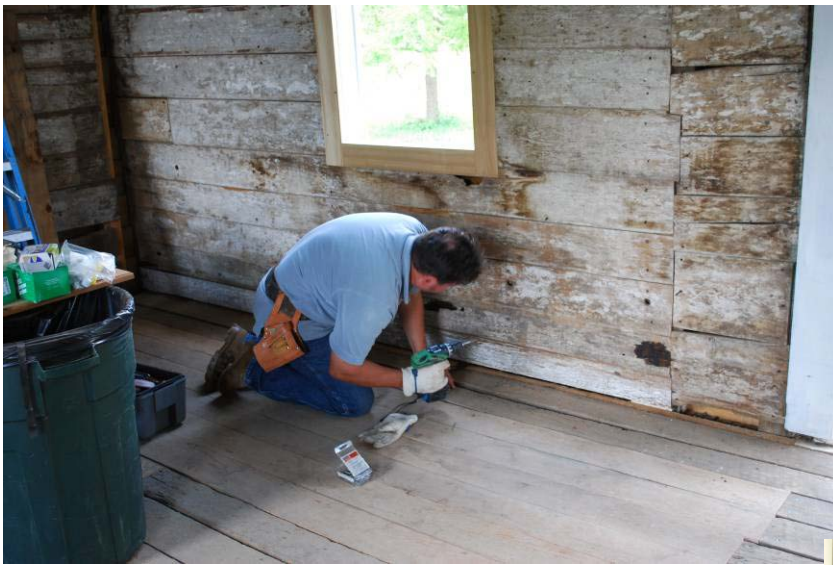
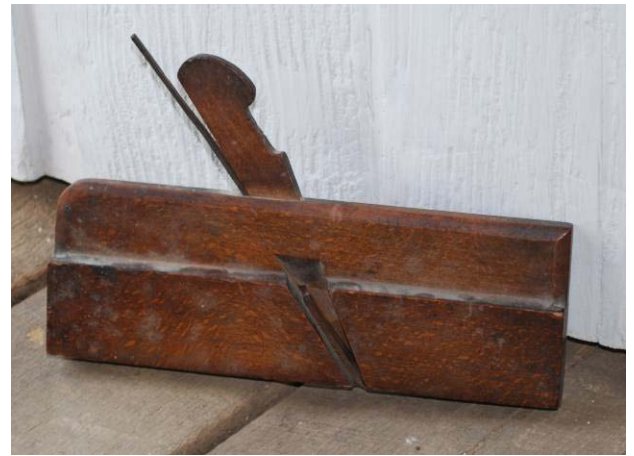
Below, Karl drills holes for his fasteners in a recycled board needed for a baseboard in the northwest corner. Brought from their tool collection in the Jamestown workshop, the historic hand planer with the exactly-

matching beading blade to replicate the bead on the surrounding late-18th-century boards is also pictured.

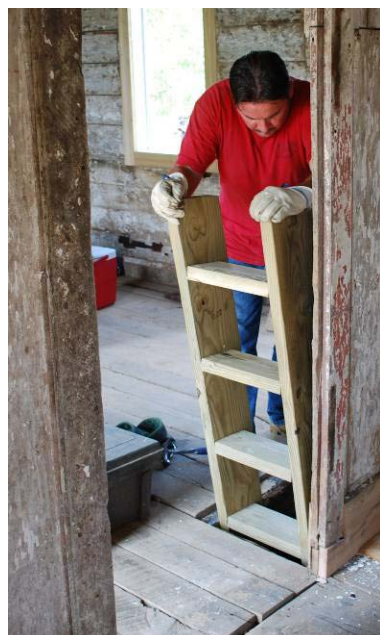
At near right, Karl drops his freshly-built wooden ladder down into the cellar opening for safer access. Pressure-treated wood serves as the identifier of the modern addition.

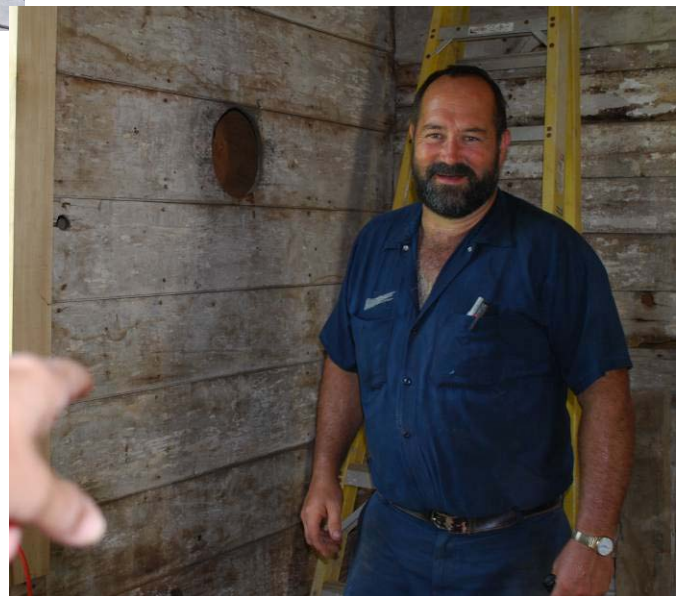
At far right, Edward Ashby is amazed at the discovery of a tenant's hazardous flue vent in a board reinserted in the northeast wall of the parlor. Lime wash and plaster infill had hidden the hole until falling out while the numbered board was stored in the shed.

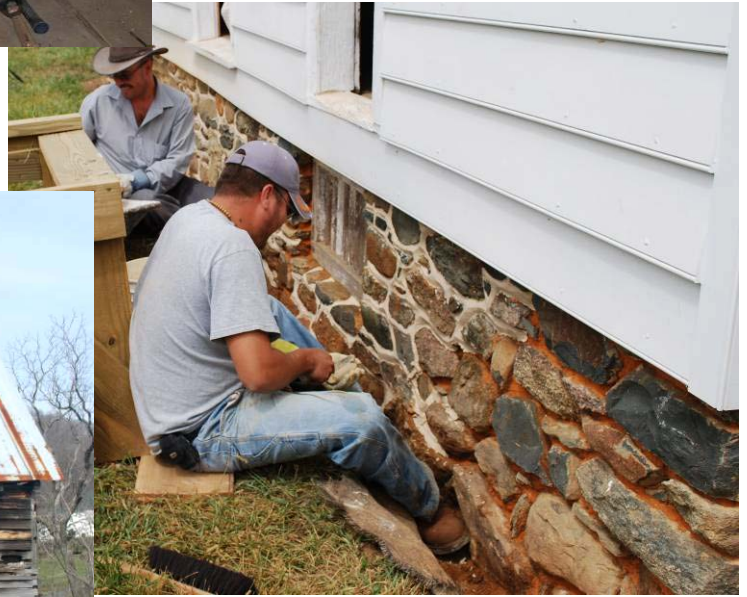
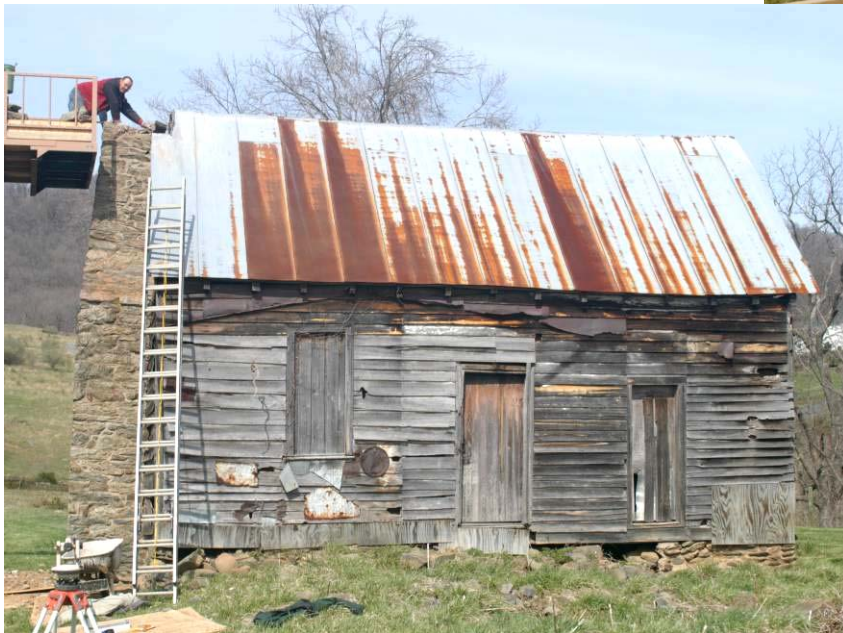
In September, Edward had stonemasons Miguel and Alejandro tuck pointing lime putty mortar to the foundation. Plywood shades this material for slow curing.
