Preservation & Stabilization of The Hollow, Summer 2009

Prepared October 2009 by local project manager/architectural historian Cheryl H. Shepherd

Representing *Preservation Virginia* & Dr. & Mrs. David C. Collins

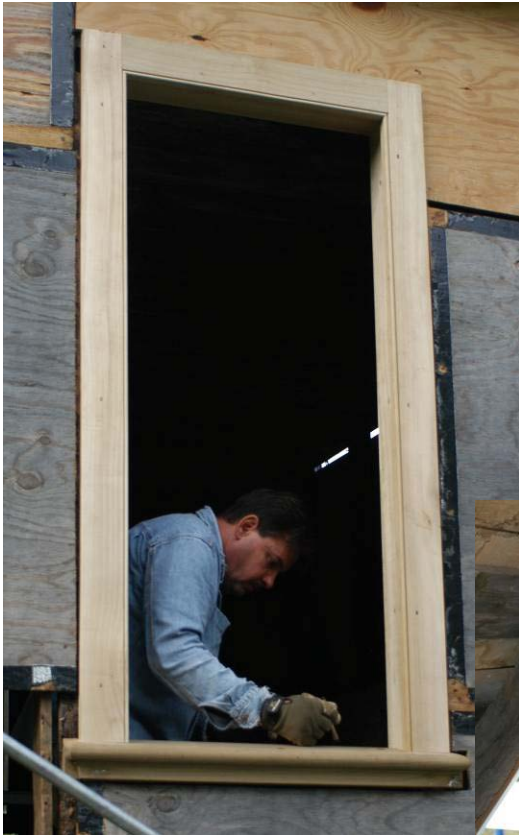
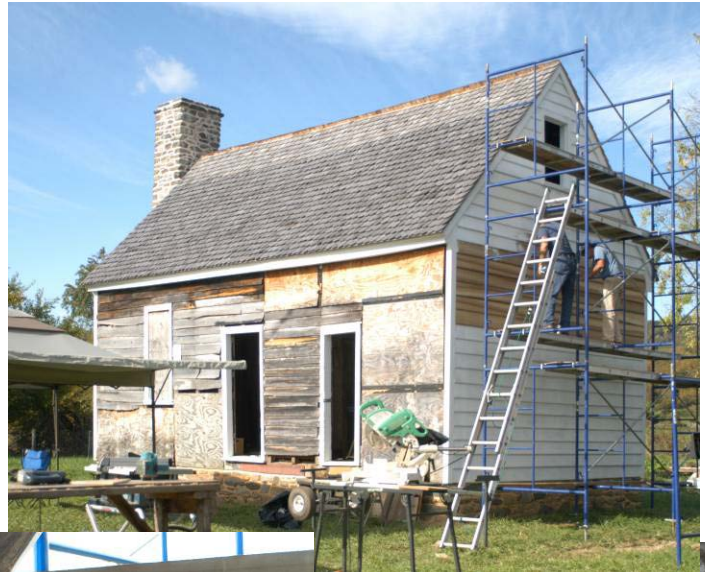
Last year, Karl, shown above finishing his beaded northwest-rear window frame, and Mike, at right after inserting his window frame to receive a four-light casement beside the west chimney on the 2nd-floor, prepared the walls for beaded poplar weatherboards. This required repair of existing window and door frames, such as the back-door frame with consolidation drying at lower right, or restoration of missing frames. Early tenants applied whitewash over *The Warrenton Virginian* newspaper to insulate cracks between boards on a board-and-batten door that Karl installed for the rear entrance. Newspaper also remains under whitewash on the partition between the hall and parlor inside the dwelling. A report on Thoroughbred Stock cattle on the door is pictured at center right. Meticulous removal of layers of lime wash to consolidate the door produced only one date, 1886, indicating that the application occurred or post-dated that year. Boards feature both watermill-sawn and circular-sawn marks of earlier creation and later repair. Unfortunately and similarly to archaeological evaluation, removal to date the interior lime wash and newspaper compromises integrity of these artifacts and future educational plans for the home. Therefore, scraping for dating information on the partition and other surfaces will not occur.

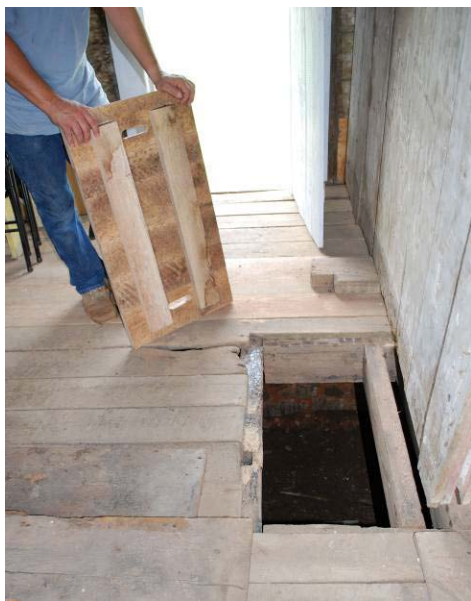
Above, Karl begins to insert his just-built cellar door that will set flush within the existing floor opening. This replaced the oversized board of plywood that haphazardly covered the entrance for many years.

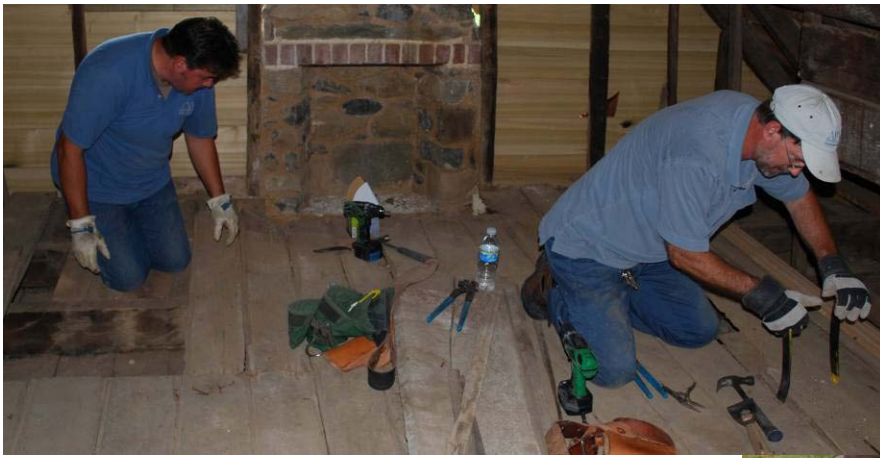
Karl and Mike shored up the floor in the garret before the end of August. They are now back on Jamestown Island making window sashes for The Hollow in between other necessary repairs to Preservation Virginia's numerous buildings.
